**Service Contract No. NDO 04/2019
Environmental Team for Environmental
Monitoring and Audit Works in
Construction Phase for the First Phase
Development of Kwu Tung North and
Fanling North New Development Areas**

**Monthly Environmental Monitoring and
Audit Report for January 2025**

Monthly Environmental Monitoring and Audit Report No. 63 (January 2025)

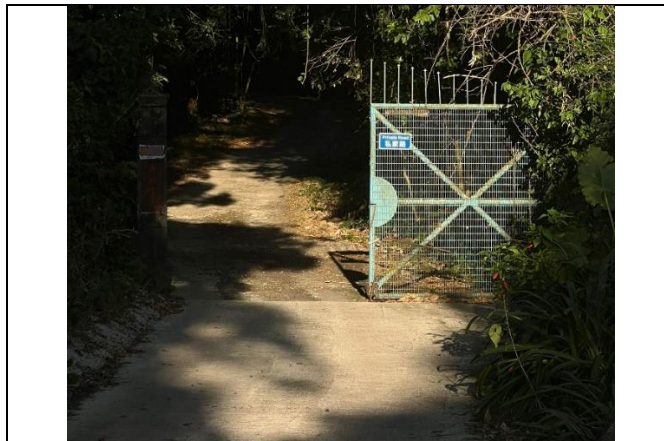
9.54 For the monitoring conducted on 10th January 2025 at Transect T5, a section of the transect route was found located within a private property and hence not accessible. The inaccessible part are shown in **Photo 1** below. The adjusted accessible transect route is shown in **Figure 11**.

Photo 1. Inaccessible part of transect T5 located within a private property.

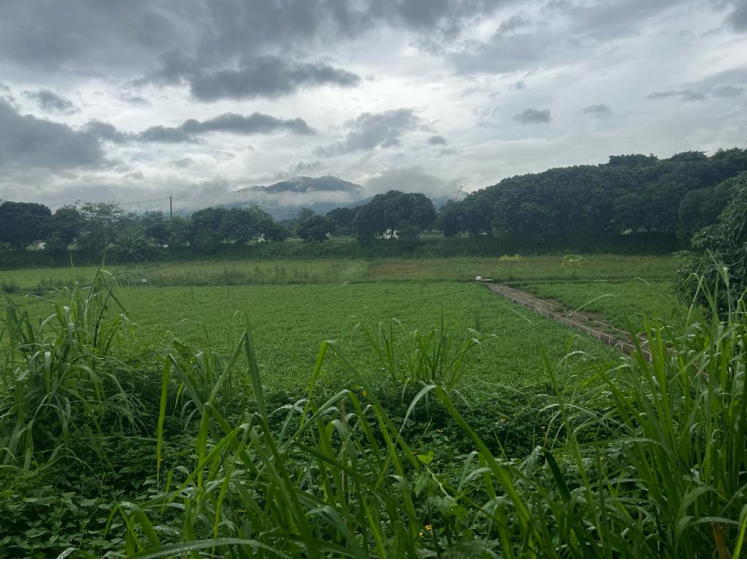
Table 10.6 Photographic Records of Site Activities in LVNP

<p>Continuing agricultural practice in existing farmland to maintain habitats in Long Valley</p>

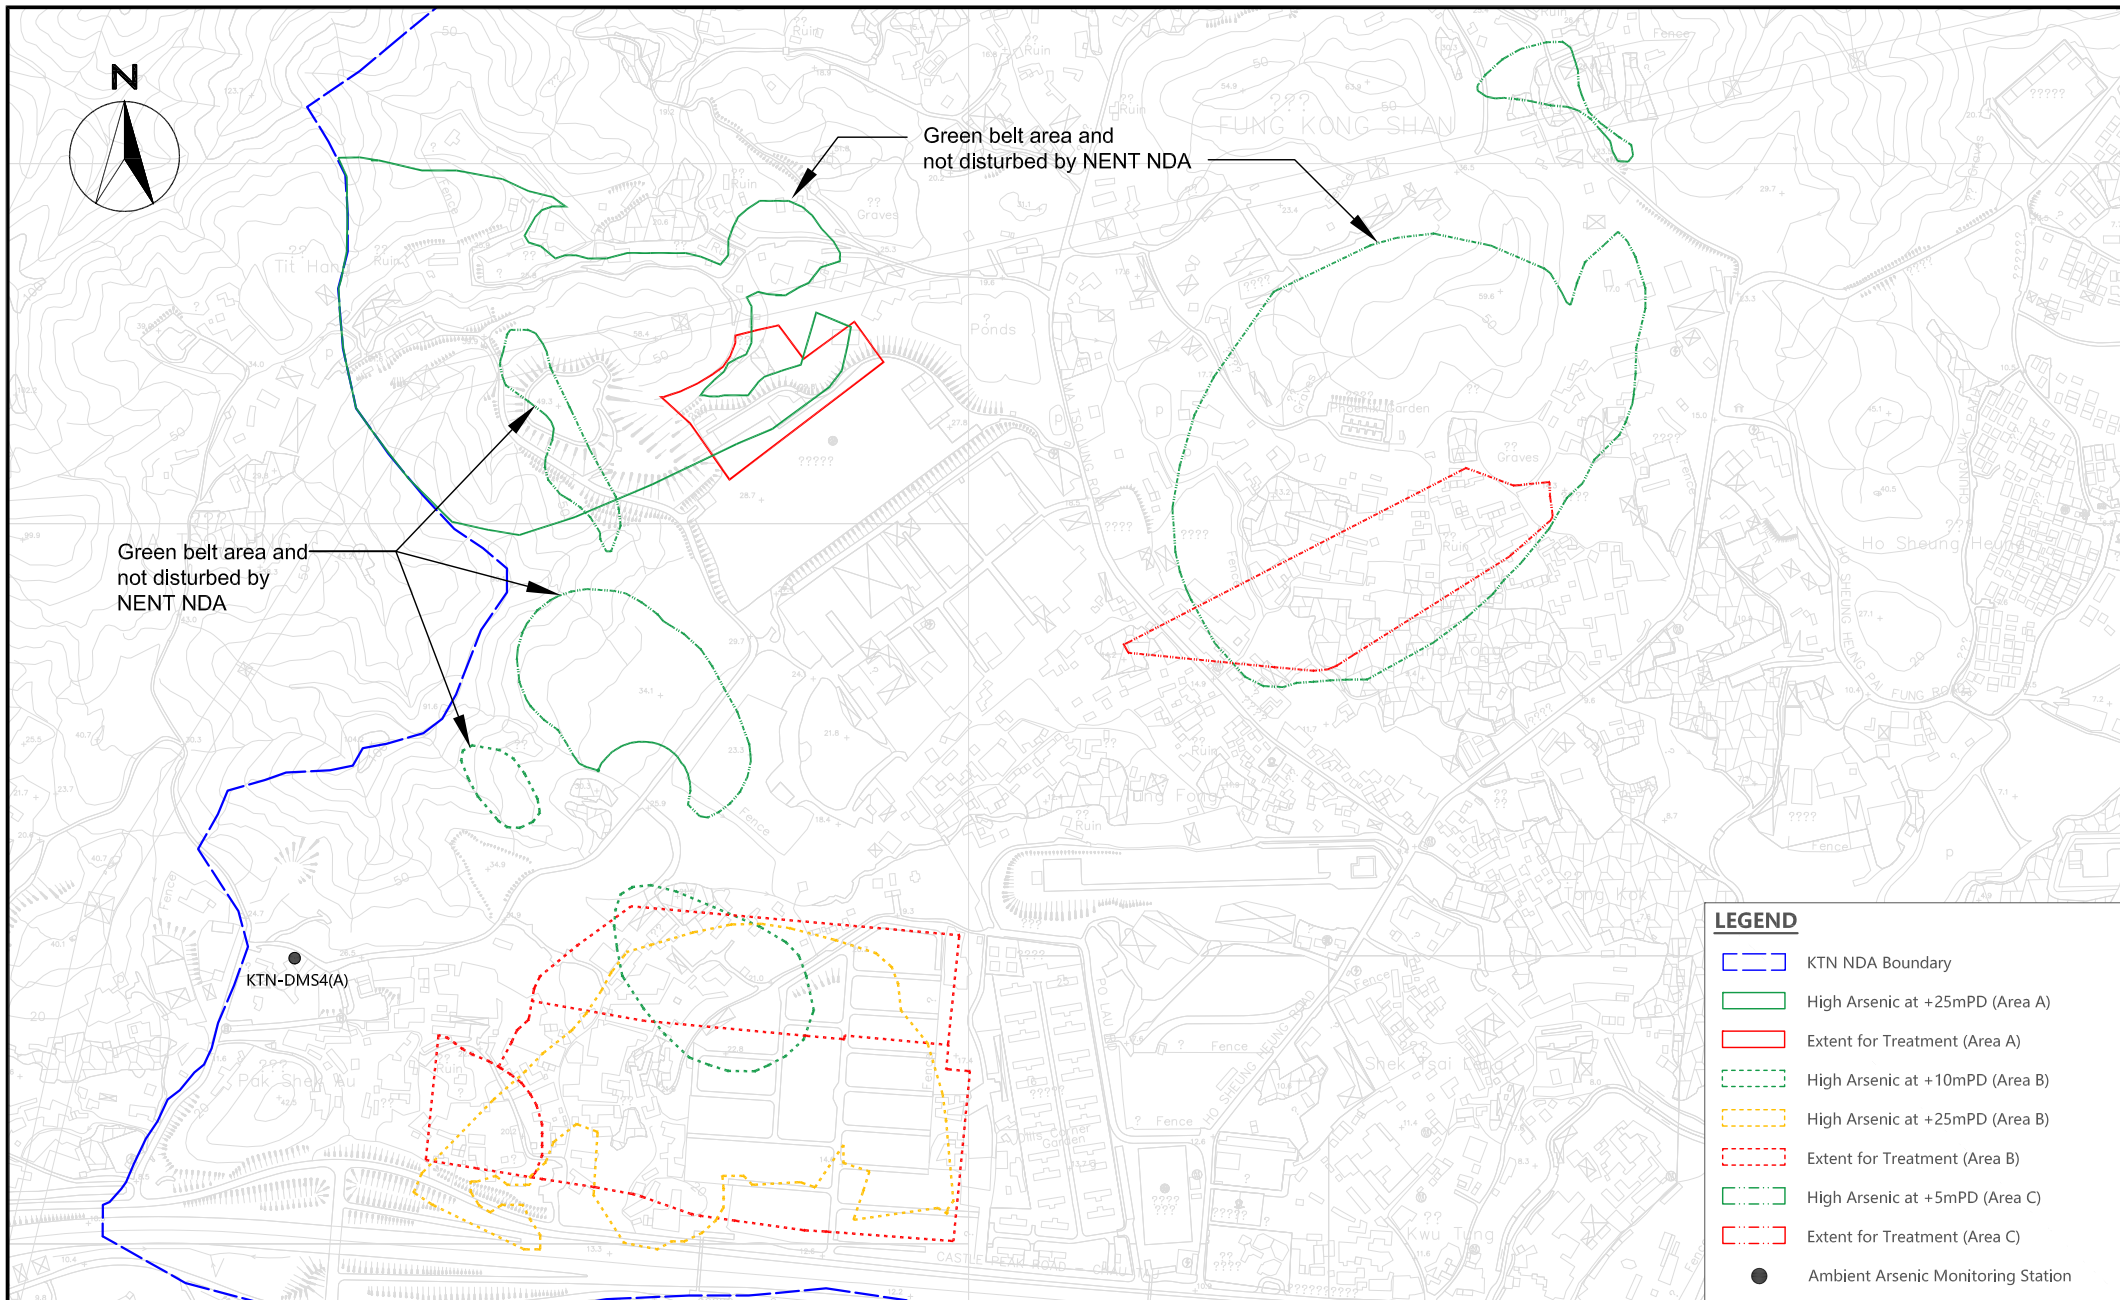
SCALE	1:20000 (A4)	DATE	Jun 2020	
CHECK	IT	DRAWN	ML	
PROJECT No.	WMA20002	FIGURE NO.	7	REV -

- — — KTN NDA Boundary
- — — High Arsenic at +25mPD (Area A)
- — — Extent for Treatment (Area A)
- - - - - High Arsenic at +10mPD (Area B)
- - - - - High Arsenic at +25mPD (Area B)
- - - - - Extent for Treatment (Area B)
- - - - - High Arsenic at +5mPD (Area C)
- - - - - Extent for Treatment (Area C)
- Ambient Arsenic Monitoring Station

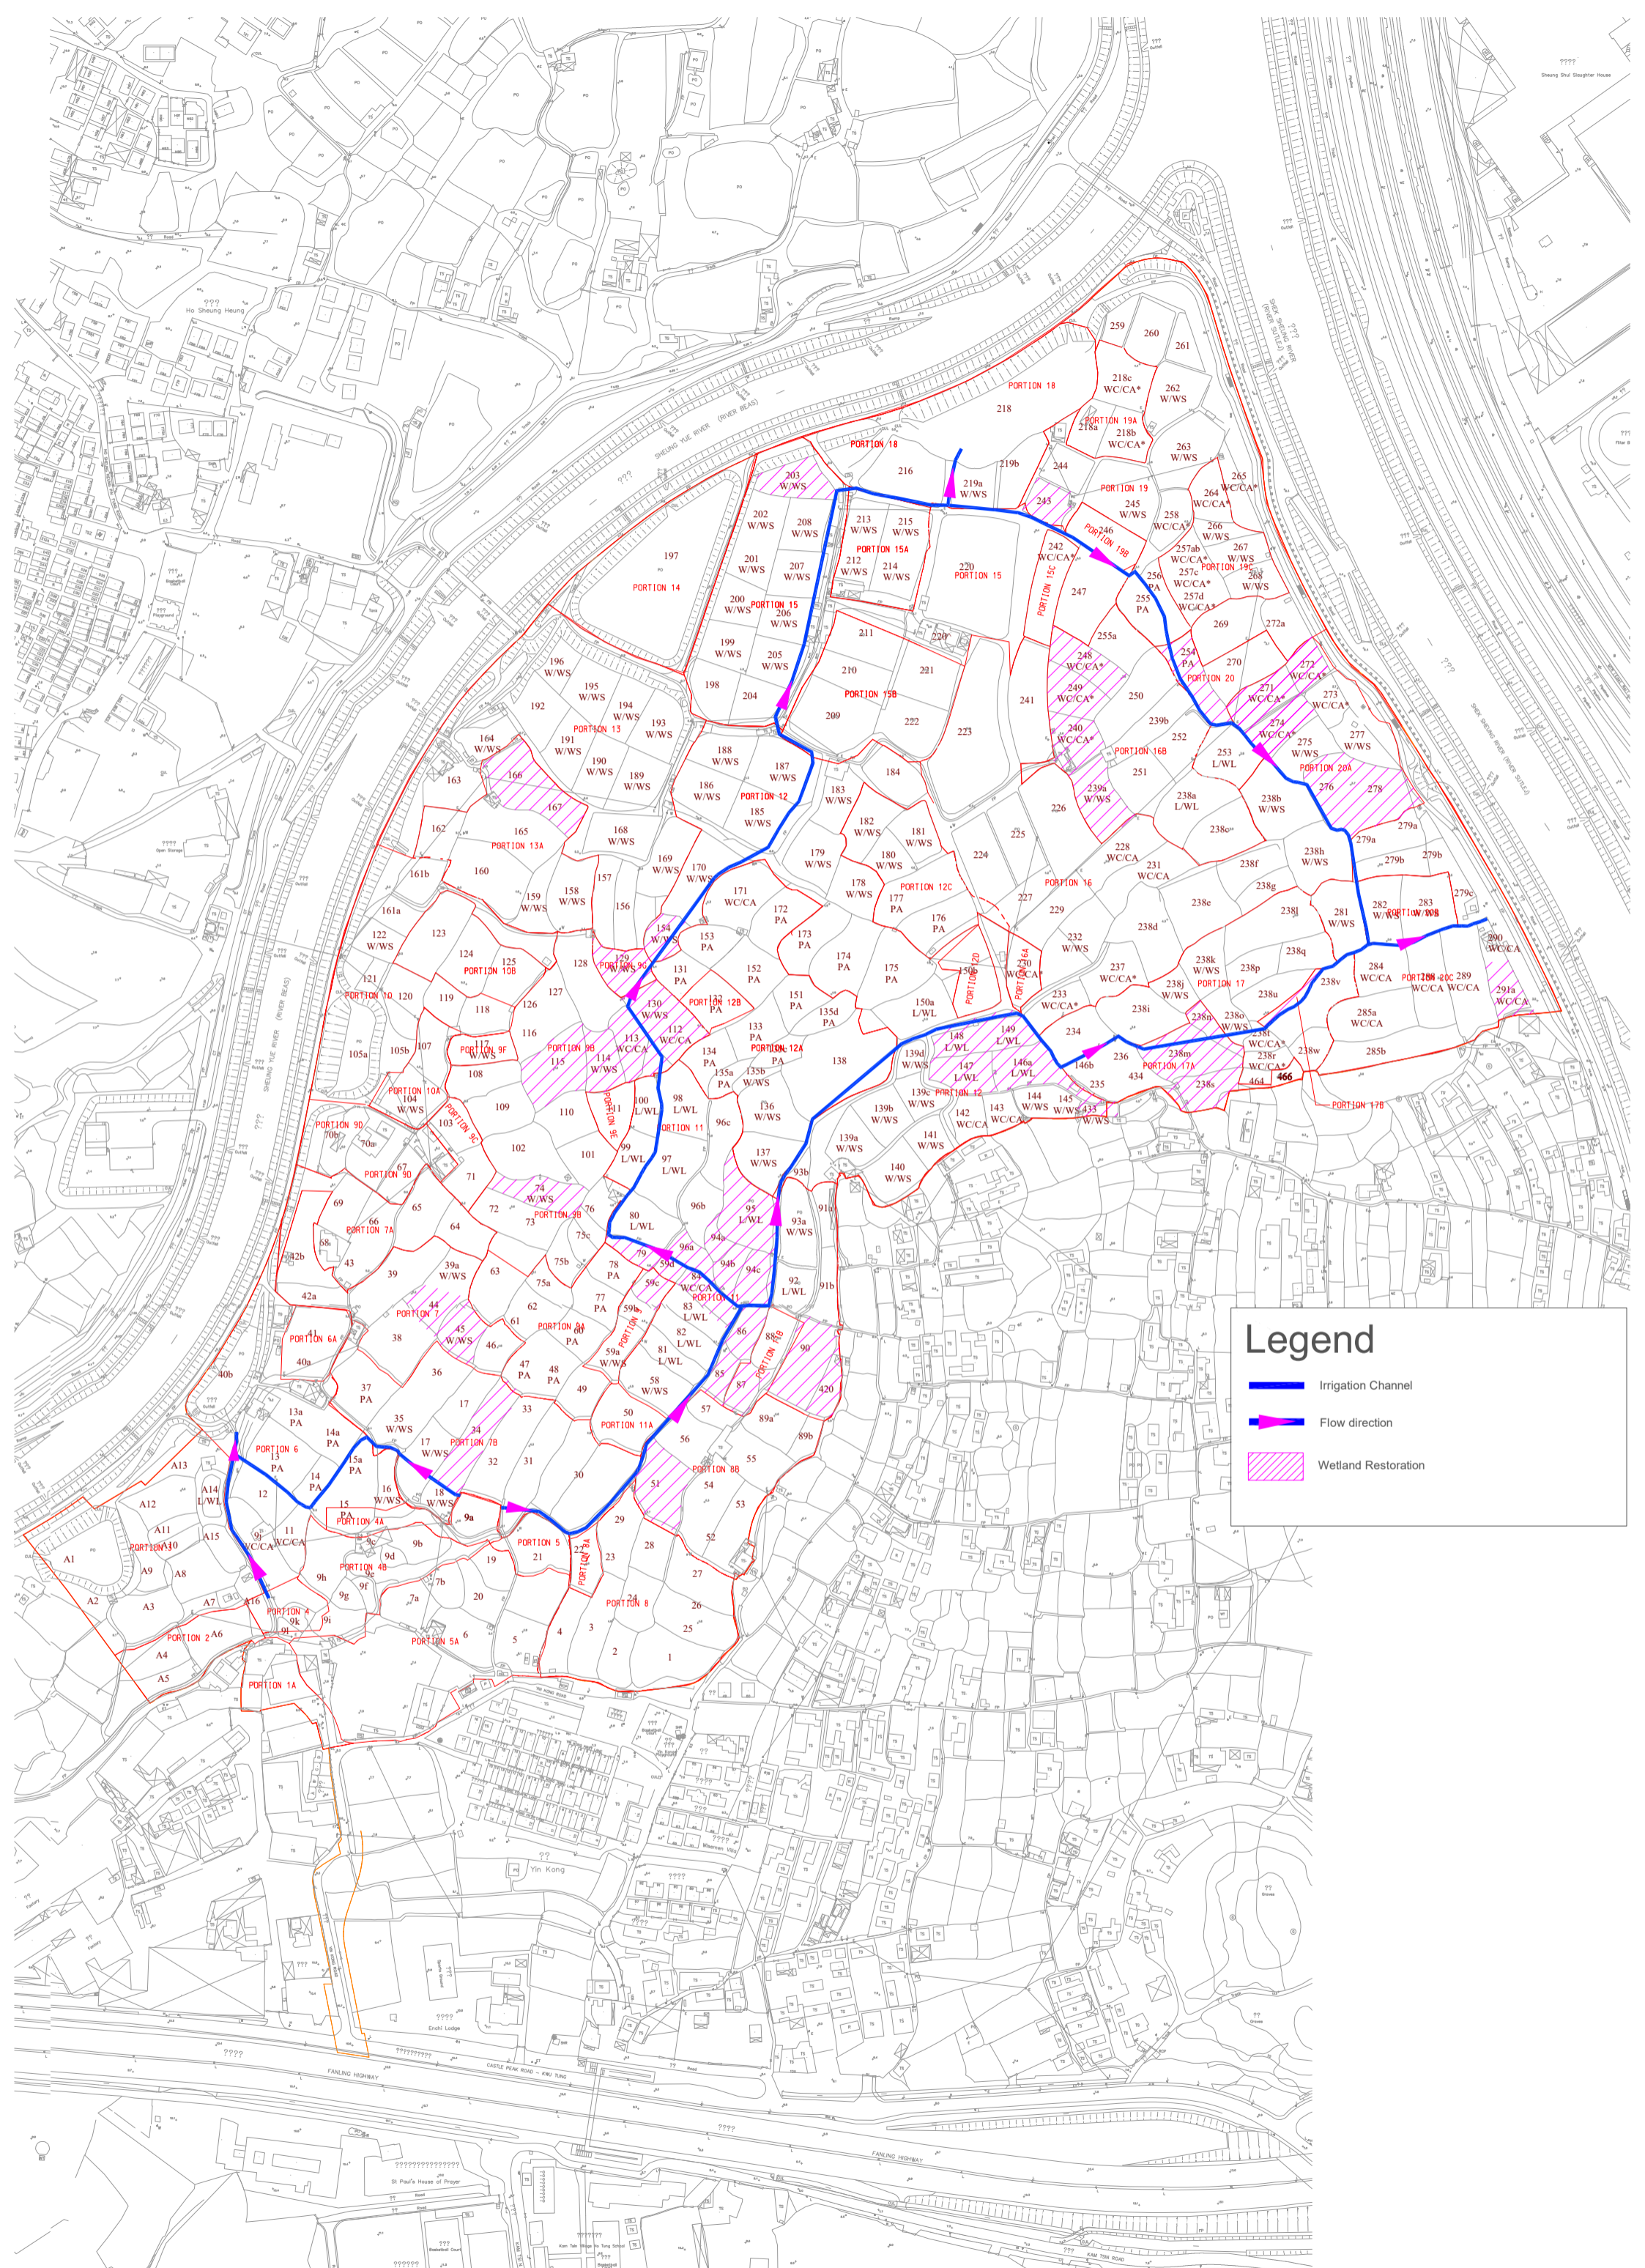
Figure 3a. The locations of wetland to be restored

- Irrigation Channel
- ▶ Flow direction
- Wetland Restoration

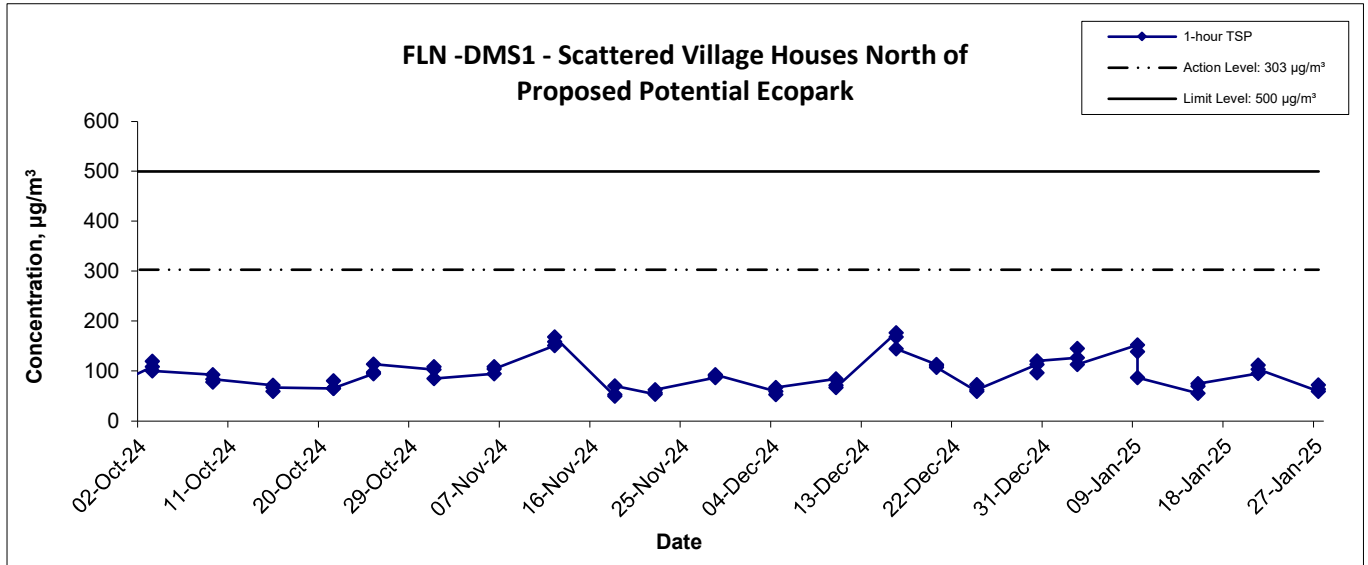
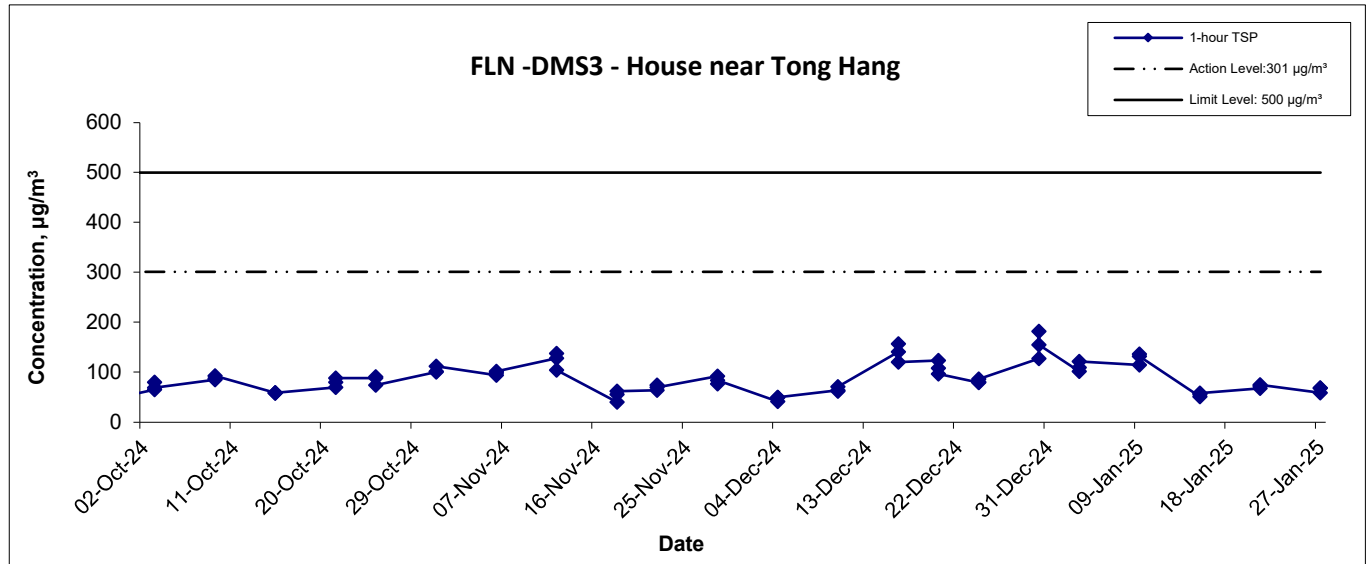
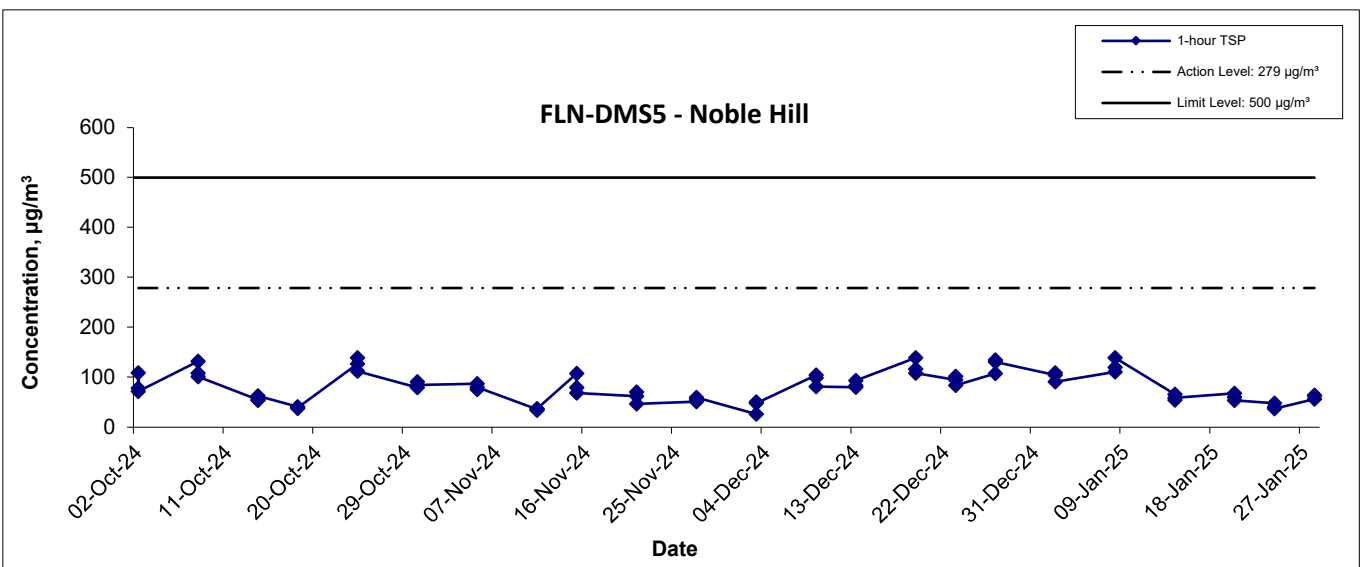
1-hr TSP Concentration Levels

Title Service Contract No. NDO 04/2019 Environmental Team for Environmental Monitoring and Audit Works in Construction Phase for the First Phase Development of Kwu Tung North and Fanling North New Development Areas Graphical Presentation of 1-hour TSP Monitoring Results	Scale	Project No.

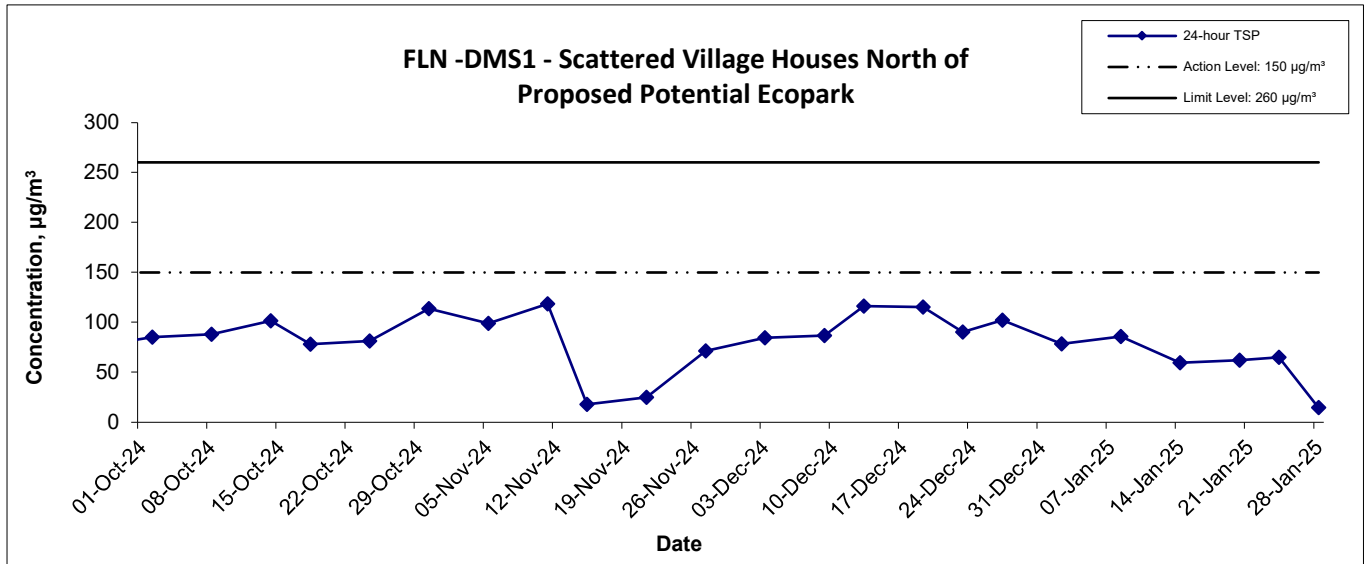
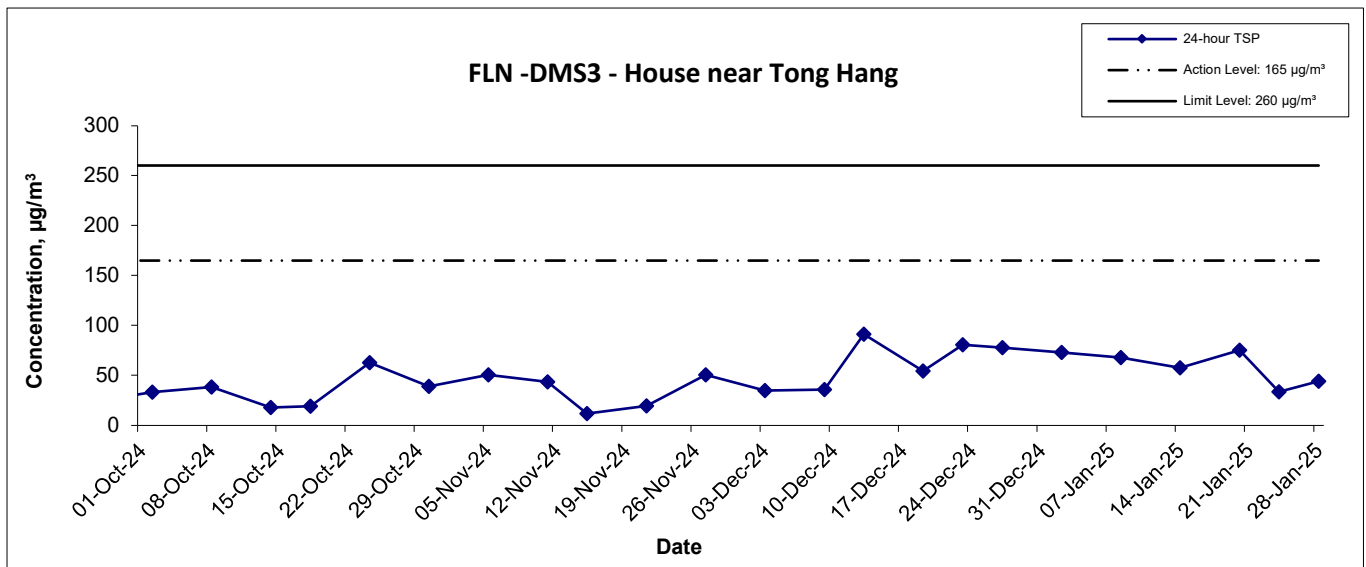
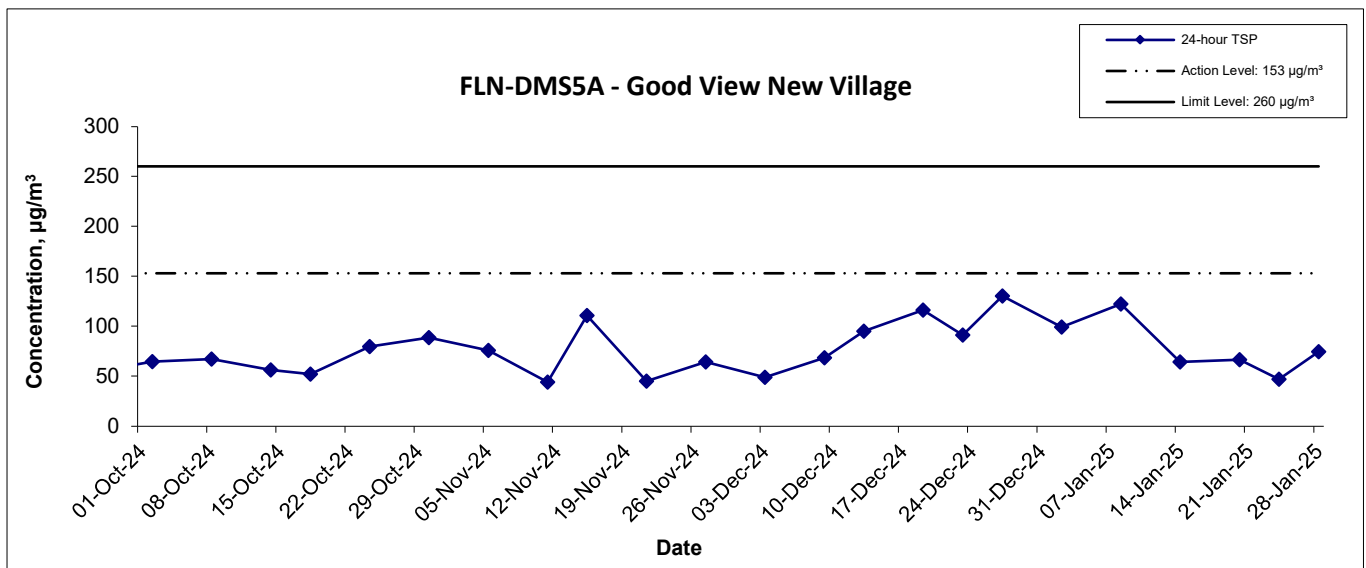
24-hr TSP Concentration Levels

Title Service Contract No. NDO 04/2019 Environmental Team for Environmental Monitoring and Audit Works in Construction Phase for the First Phase Development of Kwu Tung North and Fanling North New Development Areas Graphical Presentation of 24-hour TSP Monitoring Results	Scale	Project No.

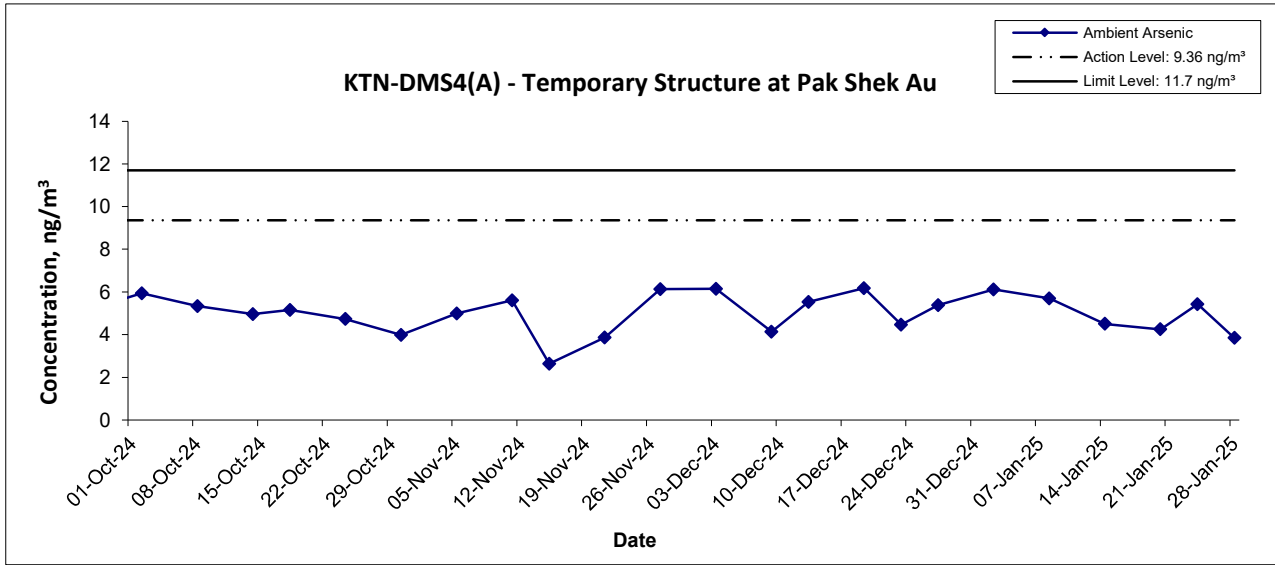
Title
 Service Contract No. NDO 04/2019
 Environmental Team for Environmental Monitoring and Audit Works in
 Construction Phase for the First Phase Development of Kwu Tung North
 and Fanling North New Development Areas
 Graphical Presentation of Ambient Arsenic Monitoring Results

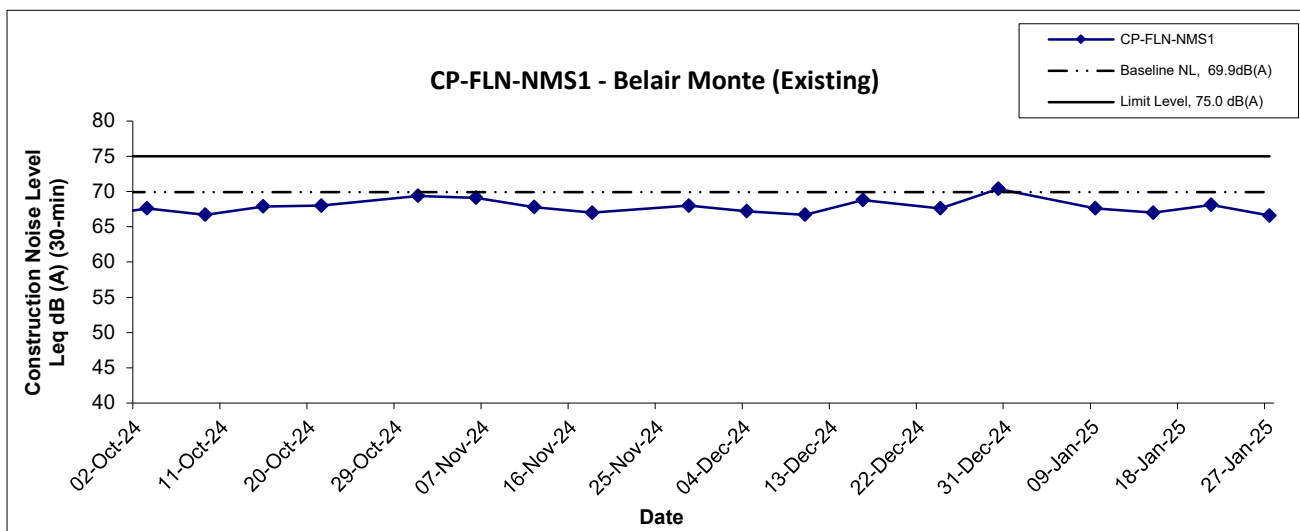
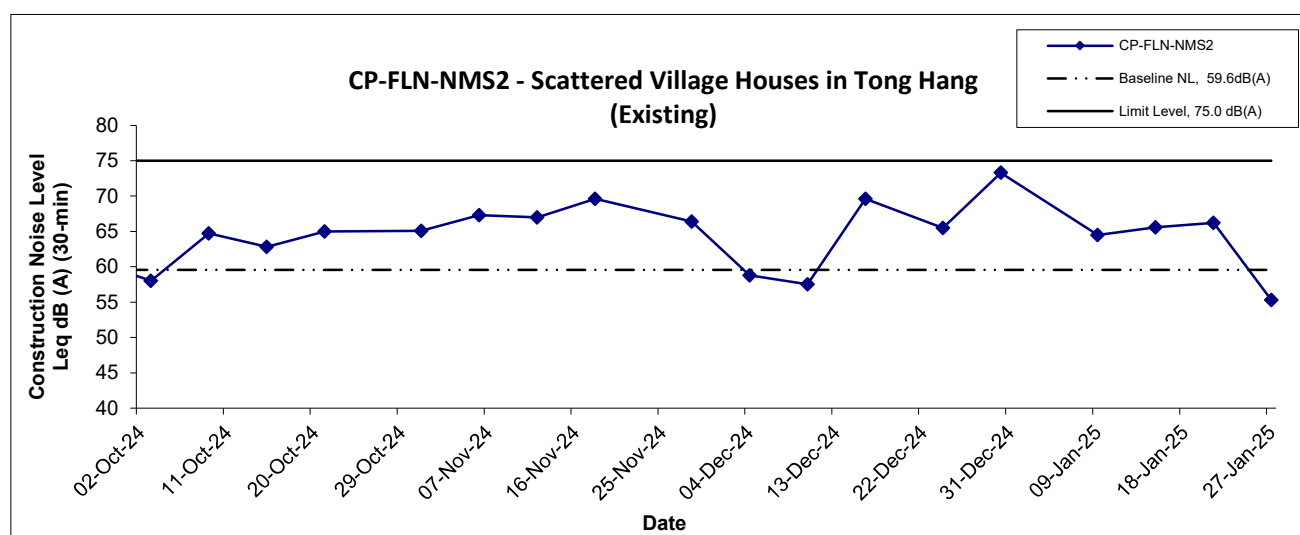
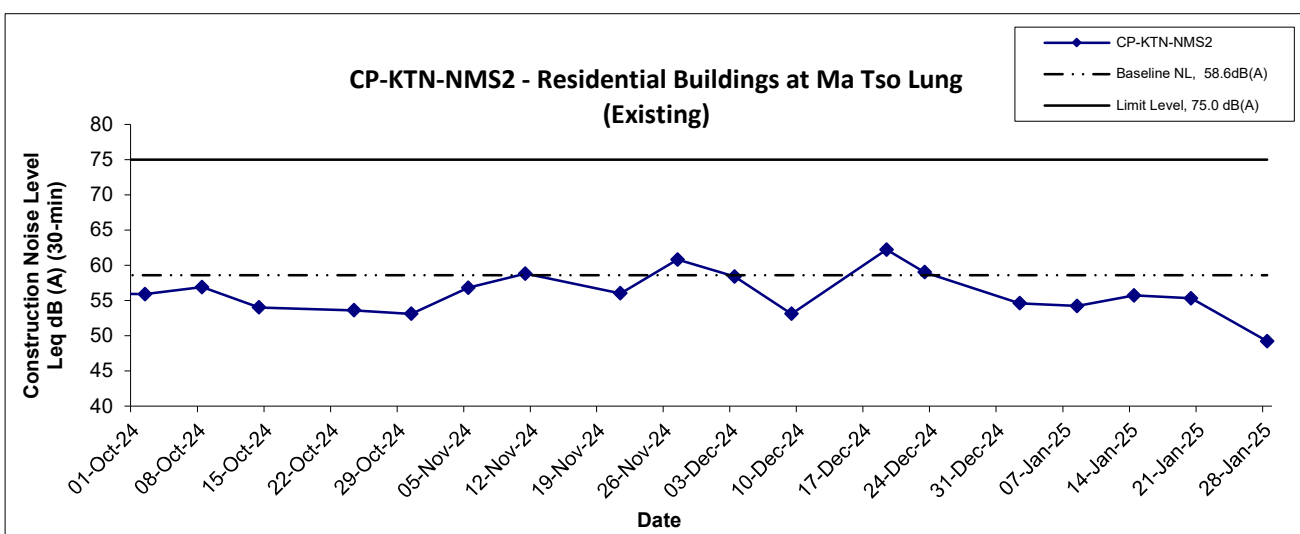
Noise Levels

Title Service Contract No. NDO 04/2019 Environmental Team for Environmental Monitoring and Audit Works in Construction Phase for the First Phase Development of Kwu Tung North and Fanling North New Development Areas Graphical Presentation of Construction Noise Monitoring Results	Scale N.T.S	Project No. WMA20002	
	Date Jan 25	Appendix F

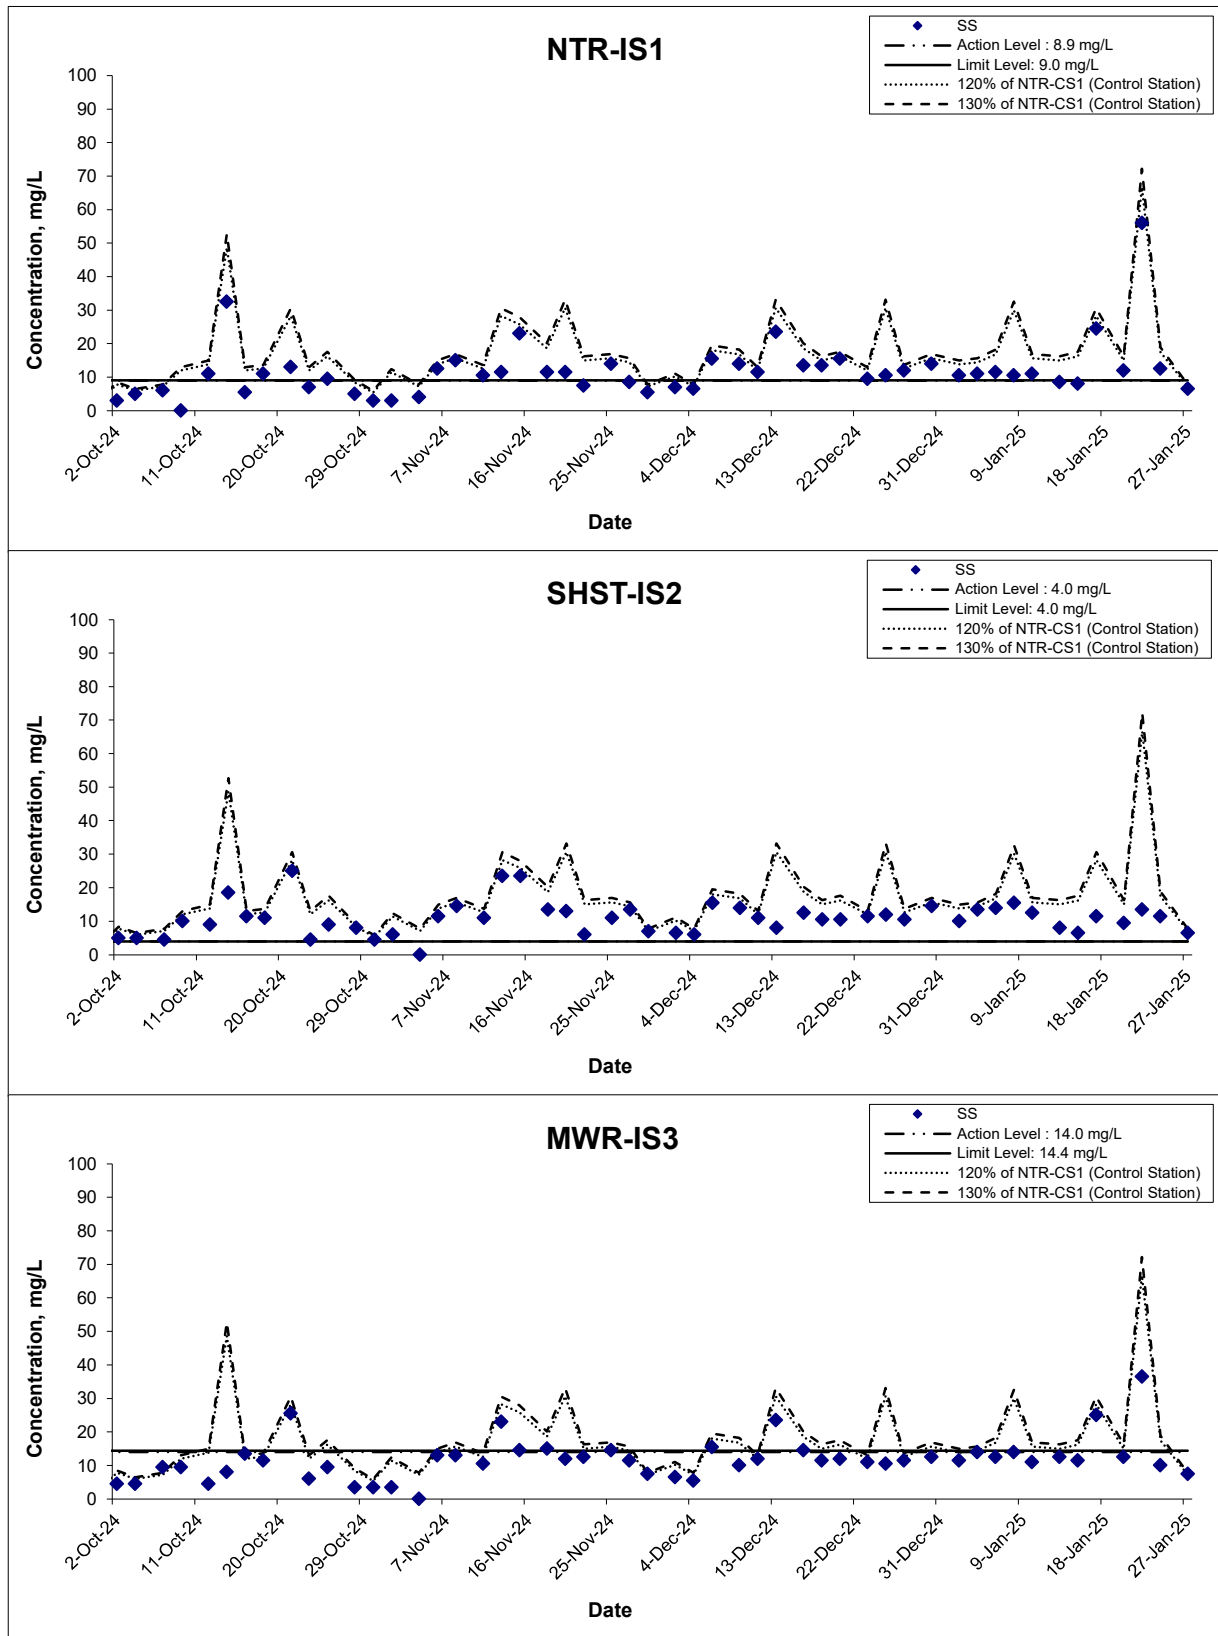
Suspended Solids (Depth-averaged)

Remark: The graphical point at zero concentration is presented as <2.5 mg/L
